檢查表的危機

雖經737機師判定為電氣系出問題，
但一時無法改正修復，其後其他異常情況竟紛至沓來。

Checklist Crisis

Anomalies grow after 737 pilots ID, but cannot fix, electrical problem

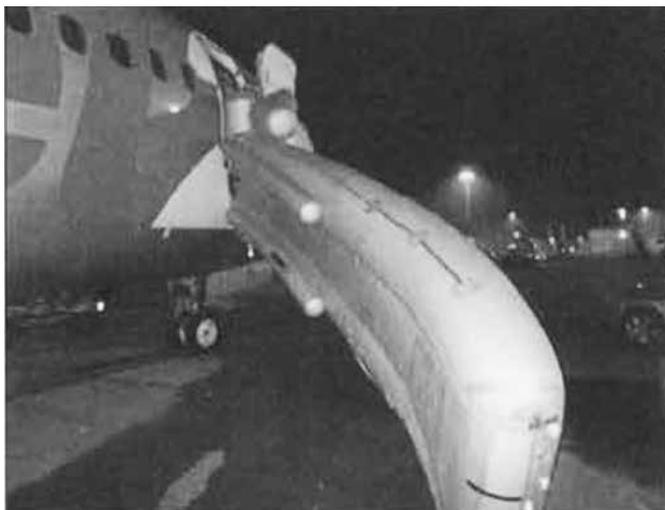
英國空難失事調查局調查官說，在施放右前艙逃生滑梯時雖係扭曲打出，實際上滑梯本身並無機械故障

事後，調查官確定，機身前方逃生滑梯釋放後呈現扭曲狀，並非該裝備失效，而是肇因於打出逃生滑梯時，機門尚未完全開啟到位，造成滑梯呈螺旋型之滾轉打出。

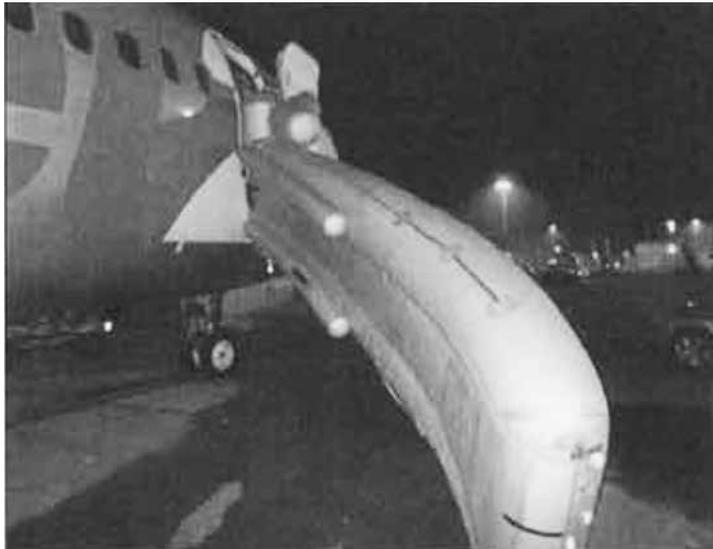
AAIB investigator say there were no mechanical problems with the Right front evacuation slide that twisted when deploying.

Investigators later determined that the twisting of the slide at the front exit was not related to equipment failure but potentially to the door not being fully open when the slide deployed, causing a corkscrew motion. ✈
