Fire resistance of self-compacting concrete beam-column sub-assembly

I.K. Fang, C.C. Lee, L.W. Chou, P.S. Chiu, T.W. Liu & J.M. Yeh

Department of Civil Engineering, National Cheng Kung University, Tainan, Taiwan

ABSTRACT: The fire resistance of three full-scale beam-exterior column sub-assembly specimens, designed according to ACI 318 seismic provisions and subjected to ISO 834 fire test, is presented. Two specimens were made of Self-Compacting Concrete (SCC) and one was made of Normal Concrete (NC). Analysis based on thermal properties of materials suggested in EC2 and ANSYS software was carried out to predict the temperature distribution of specimens. The specimens performed satisfactorily after subjected to three hours ISO834 fire exposure. The significant explosive spalling occurred in about 25 minutes after heating. The beam deflection at the end of heating was approximately 10 times that before heating. The interaction of deformation between beam and column is presented. In the residual strength test, two specimens failed in ductile flexural mode, while another one failed in shear after significant yielding. The predicted and measured temperature distribution of specimens

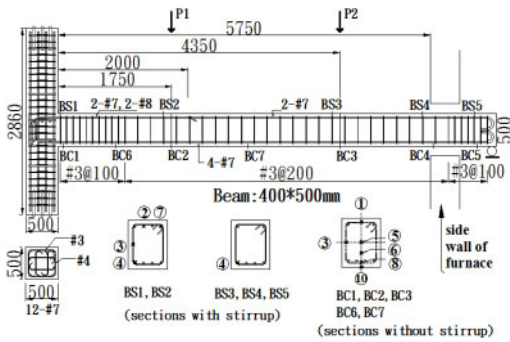
Figure 2. Reinforcement details and locations of thermal couples.

The exterior beam-column sub-assembly from a seven-storey reinforced concrete model residential building, designed according to ACI 318 seismic details, was used for the specimens as shown in Figures 1–2. The magnitude and locations of concentrated loads, P1 and P2, applied at the beam of specimens were designed to correlate the moment distribution in beam of the model residential building.

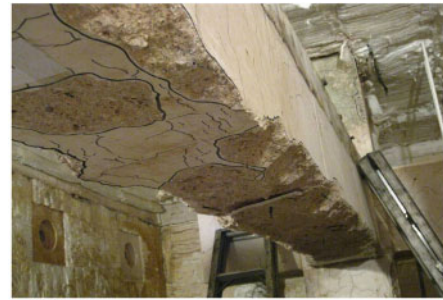
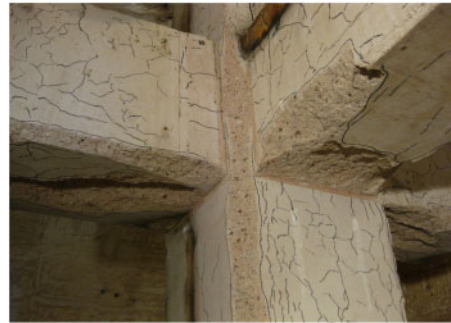
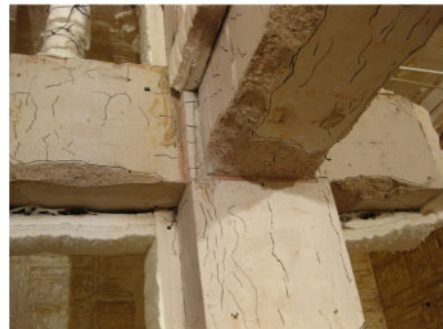
(a)NC5

(b)SCC4

(c) SCC5

(d)NC5

(e) SCC5

(f) SCC4

Figure 5. Spalling of concrete.

During approximately the first twenty five minutes of heating, concrete spalling were observed along the bottom corners of beam as shown in Figures 5a to c. The debris of spalled concrete was also found spreading at the floor of beam furnace. Severe spalling was found at the bottom of beam near column in all specimens. In this study, normal concrete specimen NC5 had more spalling at bottom of beam than SCC specimens SCC4 and SCC5. The corner spalling of lower column in the three specimens, shown in Figures 5d to f, were observed approximately in the first 18 minutes of heating. Following that spalling also occurred at some corners of beam-column joint, and at surface and corners of upper column.

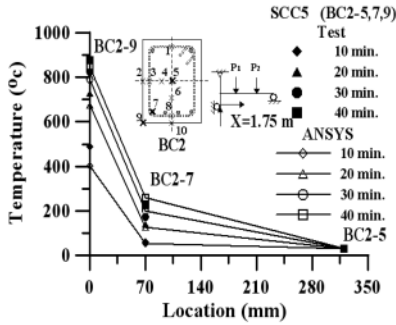
(a) Near joint (Specimen NC5)

(b) At load point P1 of beam (Specimen SCC5)

(c) At load point P2 of beam (Specimen NC5)

(d) At top of lower column (Specimen SCC5)

Figure 6. Temperature gradients of concrete.

Most of concrete spalling occurred in the early twenty five minutes of heating. The temperature gradients in beam sections near joint face and load points at early stage of heating are shown in Figures 6a-c, respectively. The temperature of longitudinal reinforcement in lower column close to joint was 580° at 180 minutes as shown in Figure 6d. The severe spalling did not expose the corner longitudinal reinforcement. The maximum temperature of bottom corner longitudinal reinforcement and vertical leg of stirrup in specimen SCC5 was 583° and 530° , respectively, at the end of heating as shown in Figure 7.

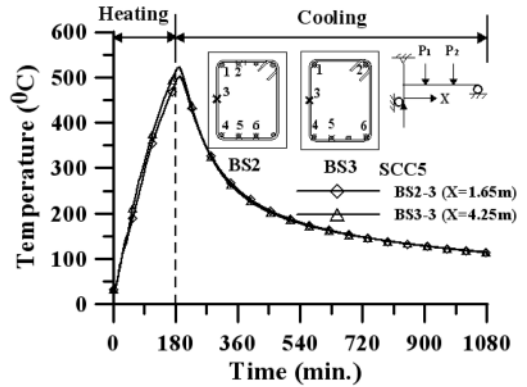
(a) Temperature of longitudinal reinforcement

(b) Temperature of vertical stirrup

Figure 7. Temperature variations of reinforcement.

The maximum recorded temperature of longitudinal tension reinforcements mentioned above is slightly over the 550° limit at single point specified in Taiwanese Standard CNS 12514.

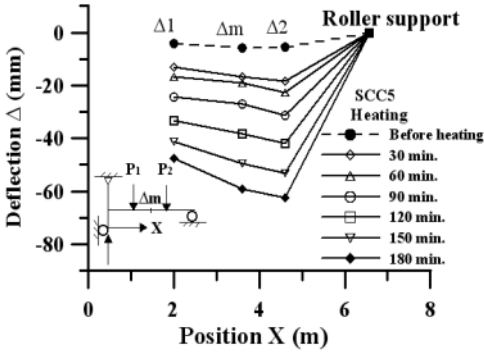
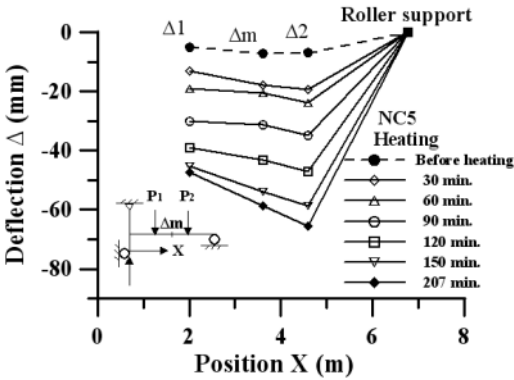
(a) Specimen SCC5

(b) Specimen SCC4

(c) Specimen NC5

Figure 8. Deformed shape of beam during heating.

The deformed shape constructed by vertical displacements recorded at two load points of beam before and during heating are shown in Figure 8. More beam deformations occurred in the early thirty minutes of heating, and the maximum value was approximately 60 mm at the end of 180 minutes of heating, which

was ten times that at room temperature. The increase of beam deformations was much smaller from thirty to sixty minutes of heating, which is believed due to the lower temperature rise caused by phase change of moisture inside concrete. Similar results were also recorded in other two specimens. The beam elongated toward both ends during the early eighty minutes, as shown in Figure 9, and then most of the elongations

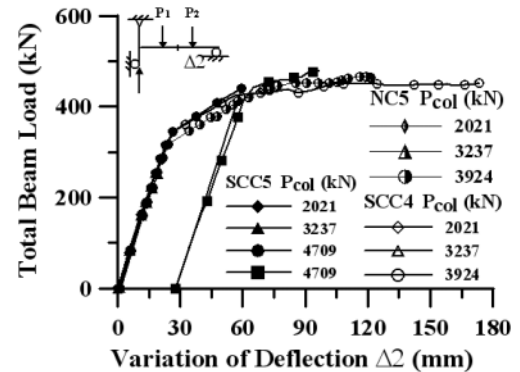
Figure 11. Variation of vertical displacement at load point P2 during residual strength test.

The ductile flexural failure with concrete crushing at top of beam near load point P2 occurred in specimens SCC4 and NC5. However, the specimen SCC5 failed in diagonal tension failure within the region of load point P1 and joint face after exhibiting significant yield behavior. The location of shear failure occurred almost right at the start of stirrup spacing changed from 100 mm to 200 mm. The reason of causing the unfavorable shear failure appears to be due to higher column load applied in specimen SCC5. Further studies on the

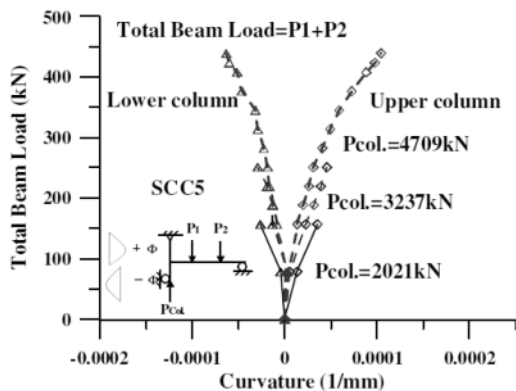
Figure 12. Variation of moment-curvature relationship of upper and lower columns during residual strength test.

The upper and lower columns exhibited slightly nonlinear moment-curvature relationship at the overload stage as shown in Figure 12.
